## LITTLE CANNON AT HIGHWAY 56

#### Little Cannon River at Minnesota Highway 56 (LCL-7)

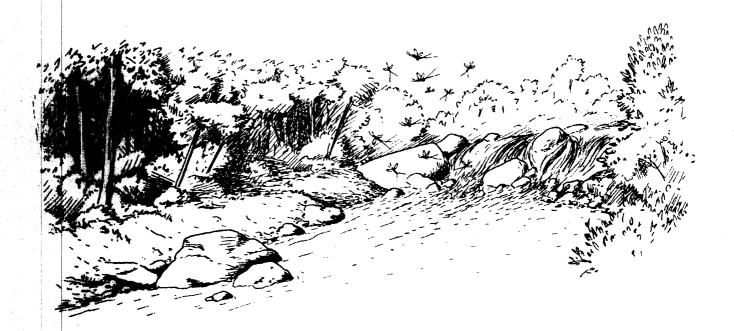
Type: Small stream near headwaters

Stream Order: 3 Drainage area: 17

Riparian: Old field (CRP) and residential

Instream: Boulders, cobble, gravel, sand, with dusting of silt in slow current

Gradient: 9.39 ft/mi
