LITTLE CANNON NEAR SOGN

Little Cannon River 1 mile upstream of Sogn (LCS-6)

Type: Midsize stream in midreach of watershed

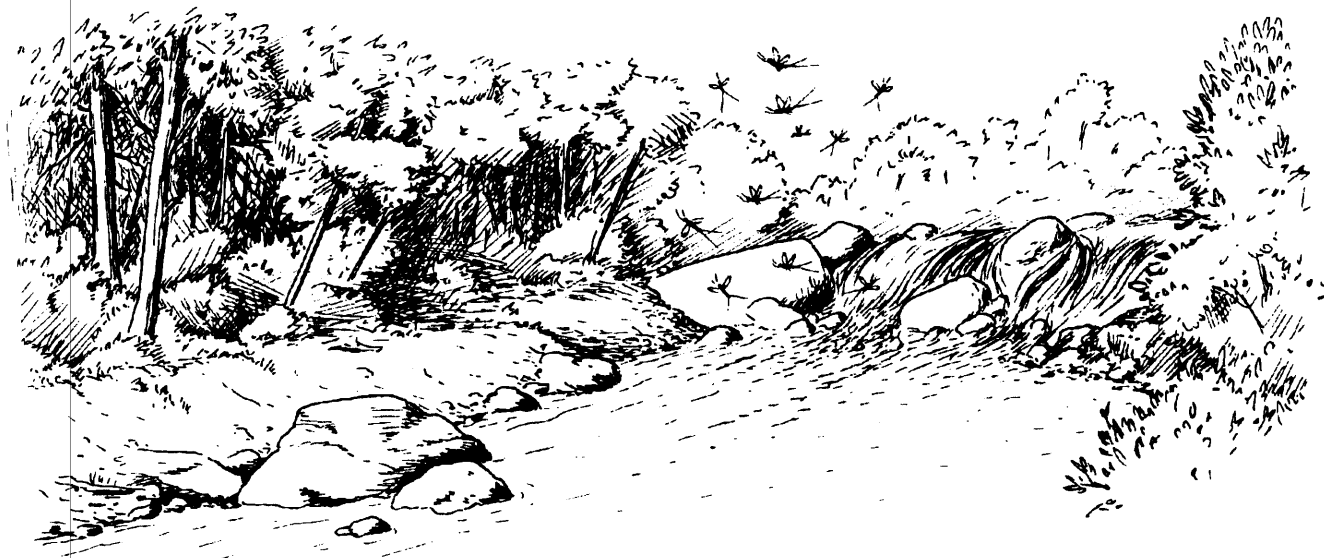
Riparian: Fenced pasture

Instream: Gravel, sand, with silt in slow current and pools

Gradient: 7.42 ft/mi

The Little Cannon River empties into the Cannon River at river mile 25 in downtown Cannon Falls. This site is located about 9 miles upstream from the mouth a half mile south of Sogn. The sample site is located in a pasture that is used by cattle during the summer months. The banks show severe signs of erosion and the cattle are contributing to the erosion. The substrate is composed of gravel and sand in the areas where the current is fast, however where the current slows much silt begins to settle out and covers the sand and gravel. The Corps of Engineers modified the channel above the bridge in 1995 by placing limestone rip rap along the outside bank that was being undercut and threatening to wash out the bridge approach on the east bank. Just upstream from this location is an artesian spring that flows all year long at a fairly constant flow. The QHEI at this site is the lowest value of all sites sampled. The low score is primarily due to the lack of instream cover and the erosion of the banks. The flow at the site varies because there is a variety of riffles, runs, and pools.

This site is most likely to always carry a larger bed load than most streams because of the steep gradient and the geology of the area. Much of the stream bank erosion could be reduced if efforts were taken to stabilize the banks and cattle were prevented from pasturing along the banks of the stream. Limiting the access of cattle to the stream would also improve the nutrient loading as well.
