E. coli Monitoring Results 2011-2012

Chub Creek (S002-533)

The Chub Creek monitoring site is located
upstream of CR-83, 0.2 miles south of
Randolph, MN in Goodhue County.

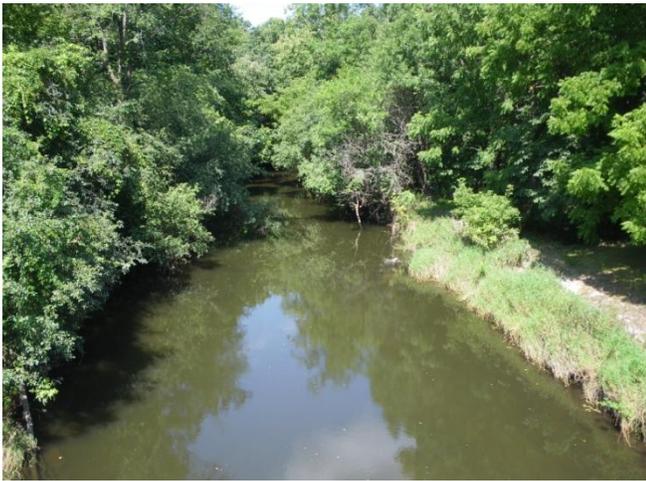
Photo from July 2012

The clarity and appearance of the water in Chub Creek is good, although clarity is quickly diminished during a rain event. The wide range of scores for Recreational Suitability further reflects this with poor scores immediately following a rain event and excellent scores during dryer conditions (Table 1). Definitions for Appearance and Recreational Suitability are provided in Table 2. *Escherichia coli* (*E. coli*) data are described further on the following page.
