E. coli Monitoring Results 2011-2012

Prairie Creek (S001-785)

The Prairie Creek monitoring site is located upstream of
310th Street, 2.5 miles southeast of Randolph, MN in
Goodhue County.

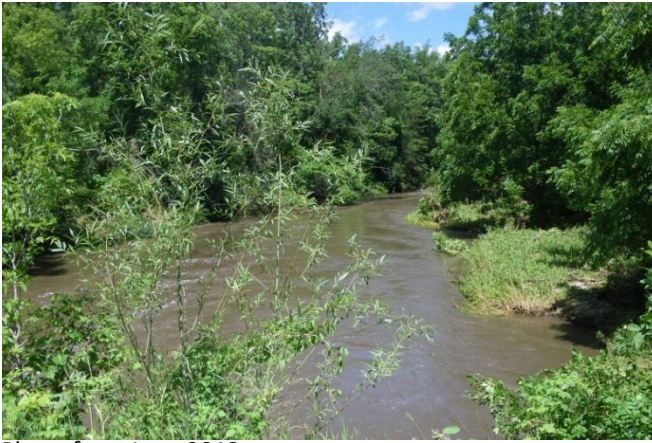
Photo from June 2012

The clarity and appearance of the water in Prairie Creek is fair. During very dry conditions, the water would occasionally be crystal clear, but was most often cloudy. The Recreational Suitability score has a wide range which reflects observations made in dryer conditions as well as following rain events. The persistent cloudiness and mud flats in late summer caused for an overall fair Recreational Suitability score (Table 1). Definitions for Appearance and Recreational Suitability are provided in Table 2. *Escherichia coli* (*E. coli*) data are described further on the following page.
