E. coli Monitoring Results 2011-2012

Turtle Creek (S003-628)

The Turtle Creek monitoring site is located upstream of southwest 22nd Avenue, 3 miles southwest of Owatonna, MN in Steele County.

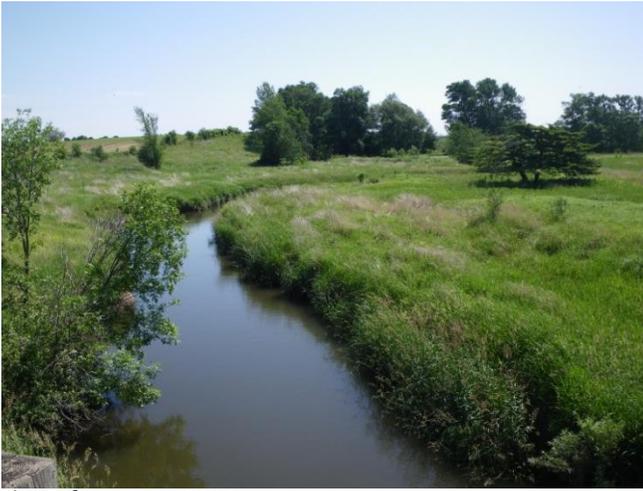
Photo from June 2012

The clarity and appearance of the water in Turtle Creek is good; however, slow moving water at the monitoring site caused for cloudy water, even in dryer conditions. The cloudy water and frequent scummy surface caused for a poorer Recreational Suitability score (Table 1). Definitions for Appearance and Recreational Suitability are provided in Table 2. *Escherichia coli* (*E. coli*) data are described further on the following page.
