## *E. coli* Monitoring Results 2011-2012

### Cannon River at Sakatah Trail (S000-545)

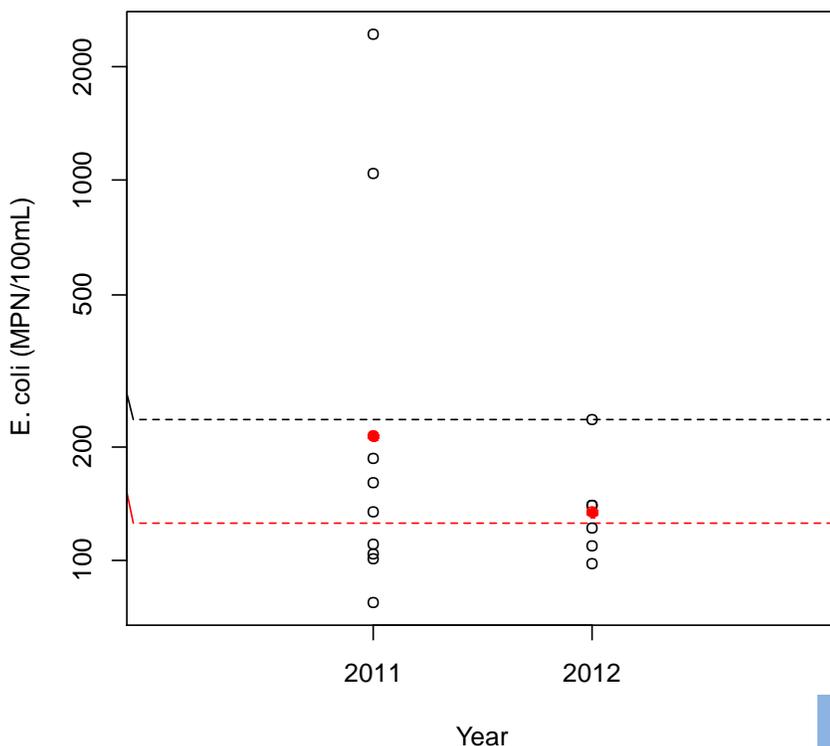
The open black circles and the black dotted line show the single sample values collected by the Cannon River Watershed Partnership and the single sample standard that the Environmental Protection Agency has set, respectively. Single samples above this dotted black line indicate that unsafe levels of disease-causing pathogens may be present in the water.

The red circles and the red dashed line indicate the geometric mean calculated by the Cannon River Watershed Partnership and the Environmental Protection Agency geometric mean standard, respectively. The geometric mean helps to dampen the effect of very high or very low numbers, thus reducing bias and allowing for meaningful statistical results. Even so, the geometric mean is still above the EPA standard for safe recreation. Additionally, this is a 90-day geometric mean which means it is quite conservative.

The *E. coli* data from 2011 and 2012 show that the single sample values are widespread, with some values over and most values within the single sample standard. During both years, the geometric mean was above the geometric mean standard which suggests that there may be disease-causing pathogens above the level that the Environmental Protection Agency has set to protect public health.

- E. coli single sample
- E. coli single sample standard (EPA)
- E. coli 90-day geometric mean
- E. coli 90-day geometric mean standard (EPA)
