E. coli Monitoring Results 2011-2012

Wolf Creek (S001-397)

The Wolf Creek monitoring site is located at
CSAH-8, 1 mile southwest of
Dundas, MN in Rice County.

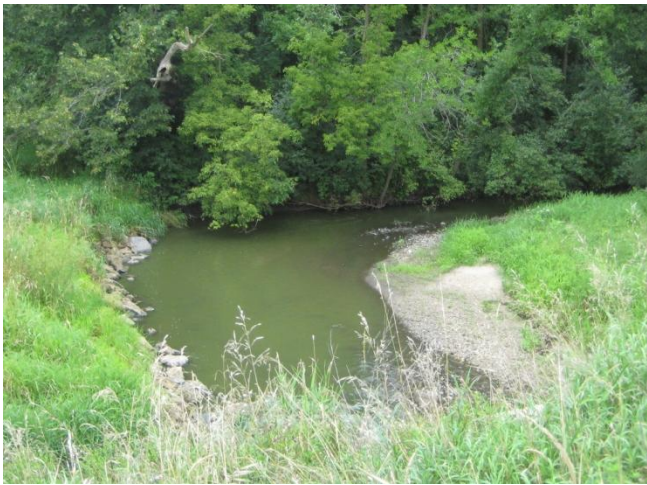
Photo from July 2012

The clarity and appearance of the water in Wolf Creek is poor. Water looked green beginning in mid-summer and would quickly become muddy after a rain event. Algae also reduced the clarity and contributed to a poor Recreational Suitability score (Table 1). Definitions for Appearance and Recreational Suitability are provided in Table 2. *Escherichia coli* (*E. coli*) data are described further on the following page.
